DEVOE LAKE DAM

PHASE I INSPECTION REPORT  
NATIONAL DAM SAFETY PROGRAM

NJ 00384

JUNE 1978

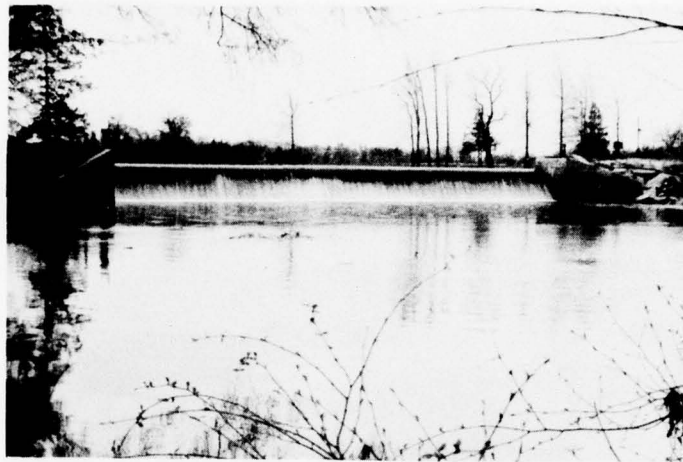
Photo 1 - View of Devoe Lake Dam seen from downstream

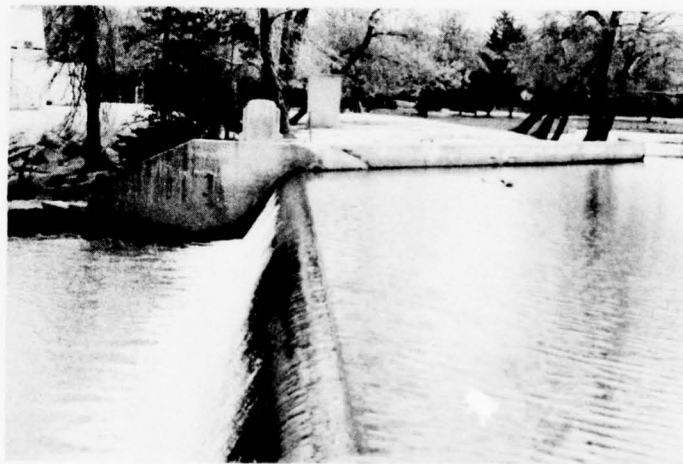
Photo 2 - View of the right abutment and upstream  
reservoir rim wall seen from the left abutment

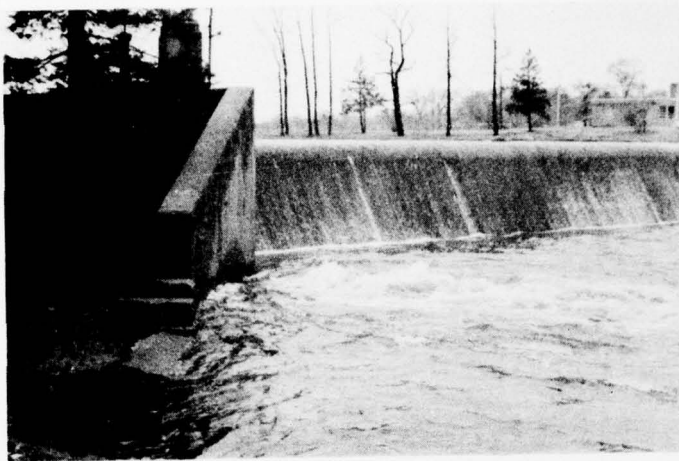
Photo 3 - View of the right abutment wingwall; the left low level outlet conduit is discharging, causing white surface water in the stilling basin area; Stilling basin apron is submerged under tailwater

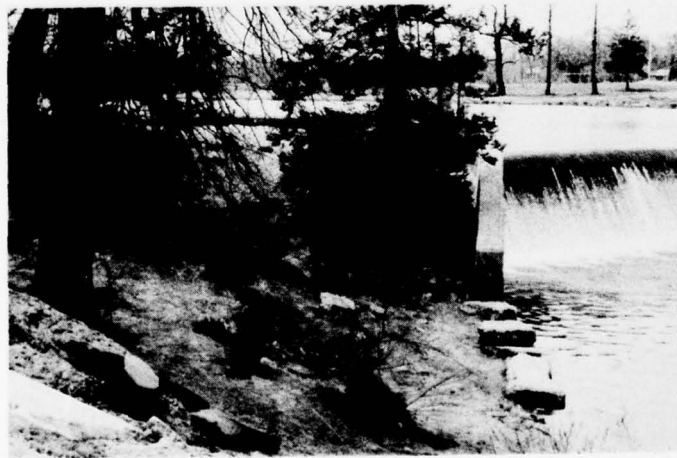
Seepage was observed coming out of the right abutment embankment section, beginning at a point approximately 8 feet landward from the end of the downstream spillway wingwall, and continuing landward for a distance of 12 feet. The leakage zone was approximately 8 feet below the top of the embankment. The leakage rate was estimated at one gallon per minute and there was some local erosion.

Photo 4 - View of the right abutment downstream face, including areas of seepage halfway between tree and end of the wingwall

The volume of seepage on both abutments is very low and is of no immediate concern; however, a program of monitoring this leakage should be initiated and the seepage channelized for volume estimation. Seepage should be checked on a monthly basis and logged by the owner's personnel.

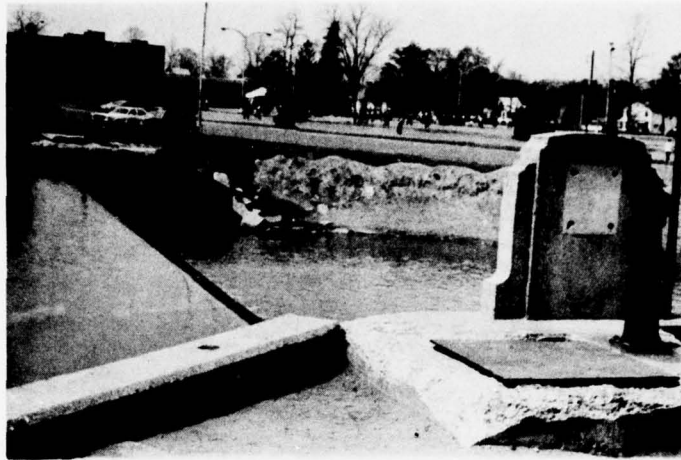
Photo 5 - View of both abutments and spillway looking toward the right abutment, showing deteriorated surface concrete at the right low level outlet conduit, deteriorated left spillway training wall, and additional dumped downstream channel protection material

Missing concrete should be replaced and deteriorated surfaces repaired by plain or epoxy concrete overlays in the spillway wingwalls and on the low level outlet gate shaft exterior surfaces. Proper fitting cover slabs or metal cover plates for the gate shafts should be provided.

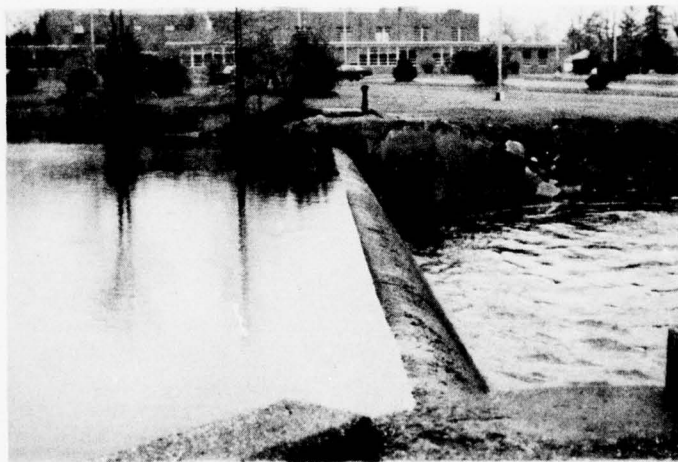
Photo 6 - View of the left abutment and spillway taken at a time when the pool was drawn down below the spillway crest for the inspection

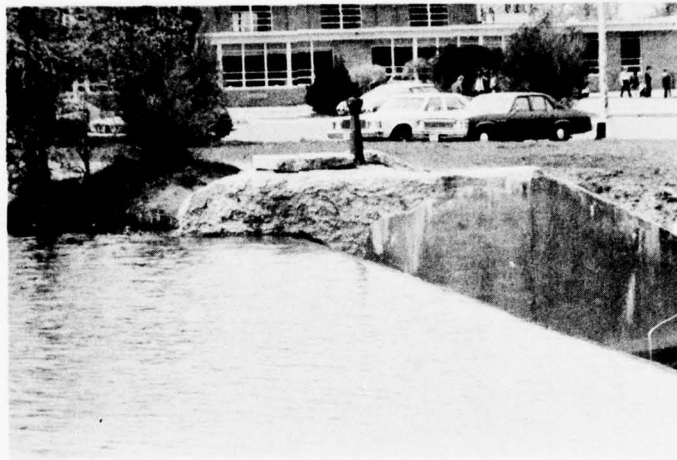
VISUAL EXAMINATION OF	OBSERVATIONS	REMARKS OR RECOMMENDATIONS
SURFACE CRACKS CONCRETE SURFACES	The left spillway wingwall is severely spalled at the top surface and at its downstream end. The upstream end of left spillway wall is missing, the rest severely eroded and spalled. Reinforcement is exposed. The right abutment wingwall is spalled and eroded at zone of weir overflow. There is algal growth on weir surfaces, but the concrete surface is in serviceable condition.	Repair and rebuild left abutment wall as required.  Surface repair of eroded zone on right abutment wall recommended.
STRUCTURAL CRACKING	There is no structural cracking in evidence caused by overloads or settlements.	
VERTICAL & HORIZONTAL ALIGNMENT	The spillway alignment is good in both horizontal and vertical directions.	
MONOLITH JOINTS	There are four monolith joints on the spillway weir section, all in serviceable condition. No misalignments or offsets were observed.

Photo 7 - Close-up of the left abutment spillway wingwall showing deteriorated concrete

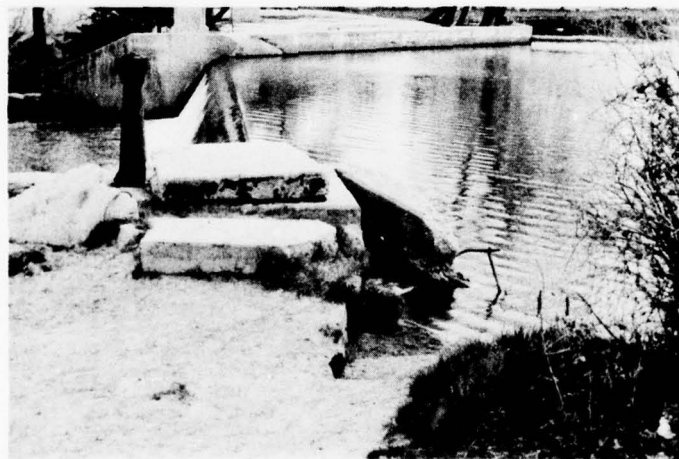
The stilling basin was under tailwater and could not be observed. The spillway wingwalls on the left abutment, upstream side were severely deteriorated and partly missing. Reinforcement was uncovered. The downstream end and top of wall was badly eroded and spalled. The right spillway wingwall was in fair and serviceable condition, although the surface has eroded at the normal spillway overflow wetting zone. The concrete upstream right reservoir wall is spalled at the interface joint between it and the right upstream spillway wingwall.

Photo 8 - View of the left abutment showing the deteriorated and missing upstream end of the spillway wingwall, and the gate operating stand for the left low level outlet conduit gate; the sheet pile cut-off is exposed in the foreground

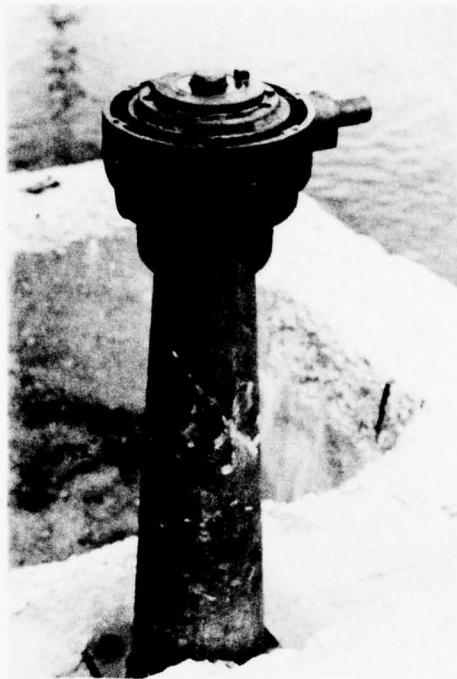
The gate leaf has a moderate amount of corrosion, however, it is not enough to affect the strength or operation of the gate. The stem and reduction gearing is in good condition. Both operating stands have missing gear cover plates.

Photo 9 - Left low level outlet  
gate operating stand  
showing the missing  
gear cover

The left sluice gate is inoperative resulting in the loss of valuable discharge capacity during storm events. It should be rehabilitated and put into service. Both right and left gate operating stands are partly vandalized and all missing parts should be replaced.

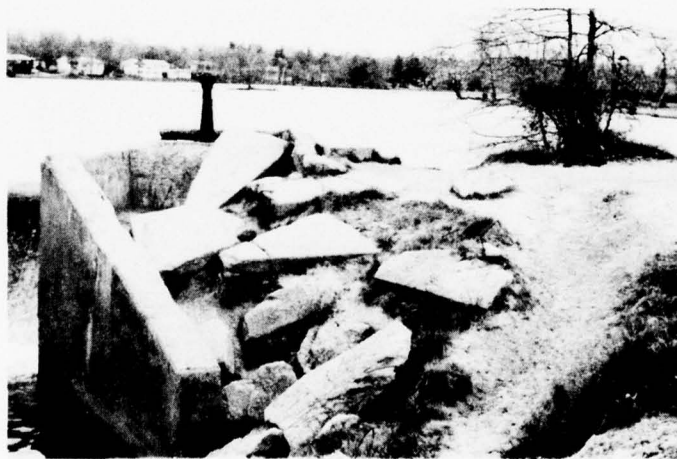
VISUAL EXAMINATION OF	OBSERVATIONS	REMARKS OR RECOMMENDATIONS
JUNCTION OF EMBANKMENT AND ABUTMENT, SPILLWAY AND DAM	Severe erosion of embankment adjacent to left downstream spillway using wall. Embankment degradation adjacent to right downstream spillway wingwall. Loss of embankment adjacent to missing part of left upstream spillway wingwall.	Regrade embankment areas adjacent to downstream spillway wingwall and protect with riprap. Regrade embankment and protect with heavy stone armor.
ANY NOTICEABLE SEEPAGE	Seepage was observed in the right abutment, beginning approximately 8 ft. landward of the downstream spillway wingwall and extending approximately 12 ft. along the abutment crest, and is estimated at one gpm. Seepage detected on the embankment at the downstream end of the left spillway wingwall and extending 6-ft. downstream at or near tailwater level. Flow estimated at one gpm.	Channelize seepage and monitor estimated seepage flow at weekly intervals.

Photo 10 - Left abutment wingwall looking upstream, showing  
the eroded area in back of the spillway wingwall

The erosion in these areas can affect the safety of the dam and the area behind the left spillway wingwall should be regraded and protected by large size stone riprap on suitably graded bedding. Stone protection should be added behind the right downstream spillway for the same reason although observed erosion and sloughing are not serious on this side. The area of embankment at the missing portion of the left upstream spillway wingwall should be regraded after the spillway wall has been rebuilt, and protected by stone riprap.

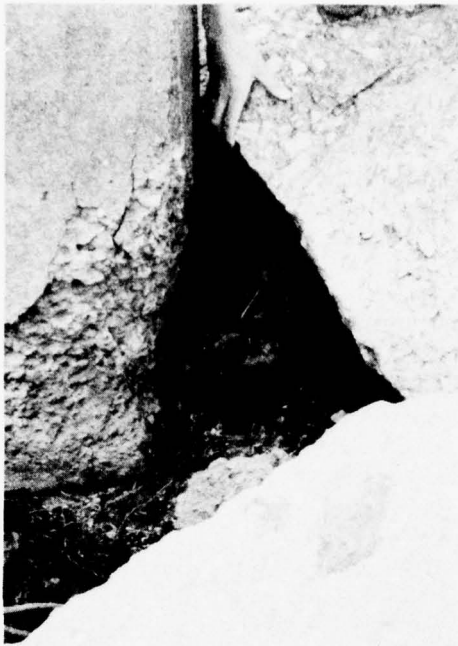
Seepage was observed in the left abutment coming out at the downstream end of the left spillway wingwall and continuing 6 feet downstream along the downstream channel bank. The seepage rate was estimated at one gallon per minute. There was general erosion on both abutments, and the area behind the left downstream spillway training wall is severely eroded and has been partially protected by dumped concrete slabs.

Photo 11 - Downstream end of the left spillway wingwall showing concrete deterioration and source of abutment seepage adjacent to it

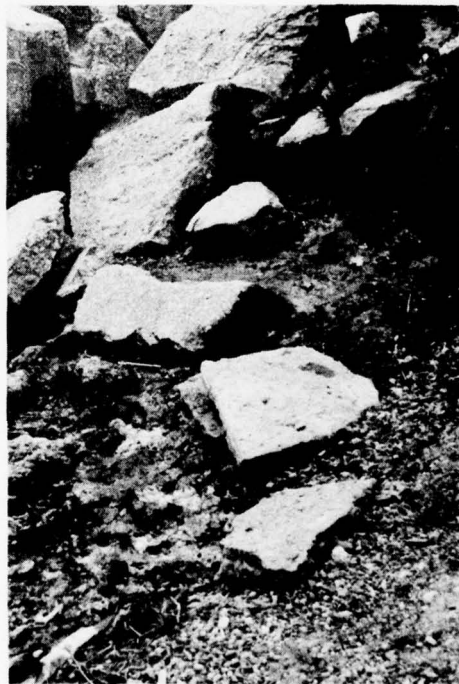
Photo 12 - General stream bank area downstream of the left spillway wingwall showing evidence of seepage

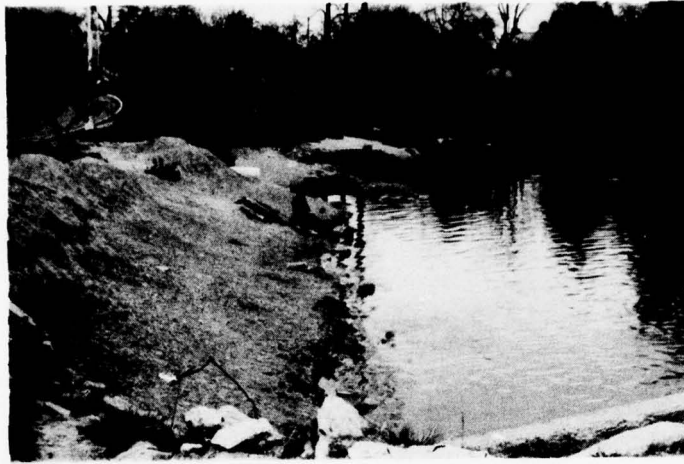
Photo 13 - View of the left downstream channel bank taken from the dam; additional dumped bank protection material has been placed

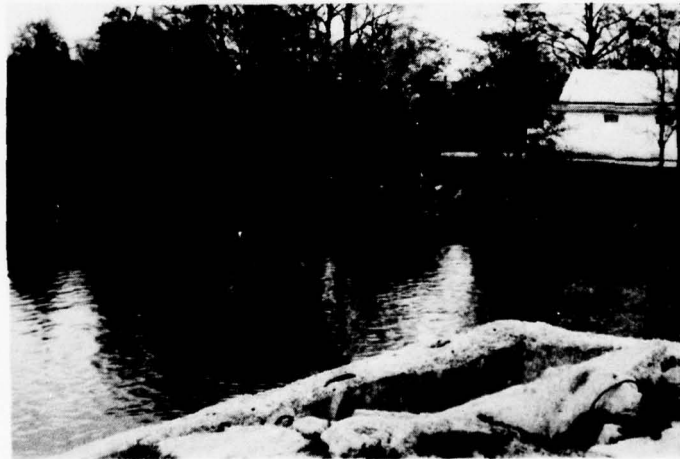
Photo 14 - View of the right downstream channel taken from the left dam abutment

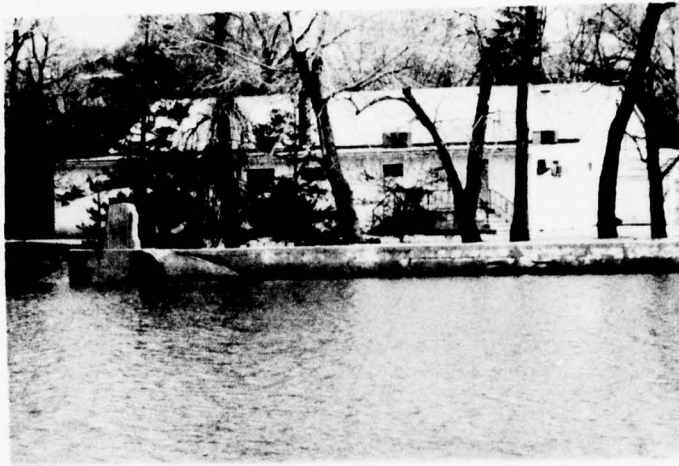
Photo 15 - View of the upstream reservoir rim wall on the right abutment

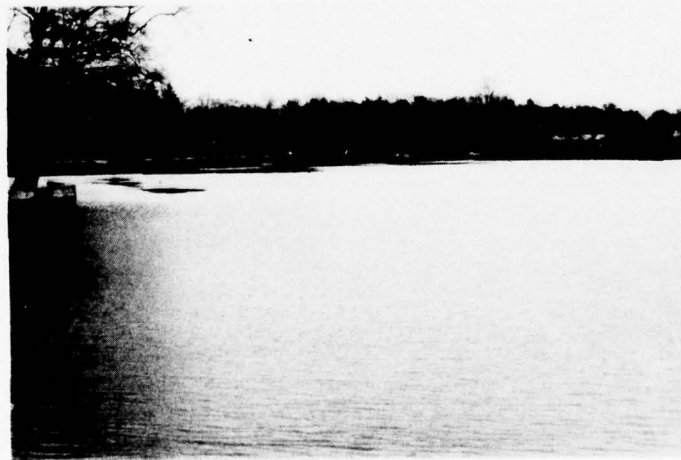
Photo 16 - View of the right reservoir rim taken from the dam axis
